**Hart Mine Marsh:**  
**Existing Conditions Report**  
**April 30, 2007**

*Work Done to Date Regarding Evaluating the Potential of Restoring  
the Cibola National Wildlife Refuge's Hart Mine Marsh Unit*

**Supplied to USBR Lower Colorado**  
(Gregg Garnett)

**USFWS Region 2**  
(Andrew Hautzinger, Darrell Kundargi  
& Patrick Donnelly)

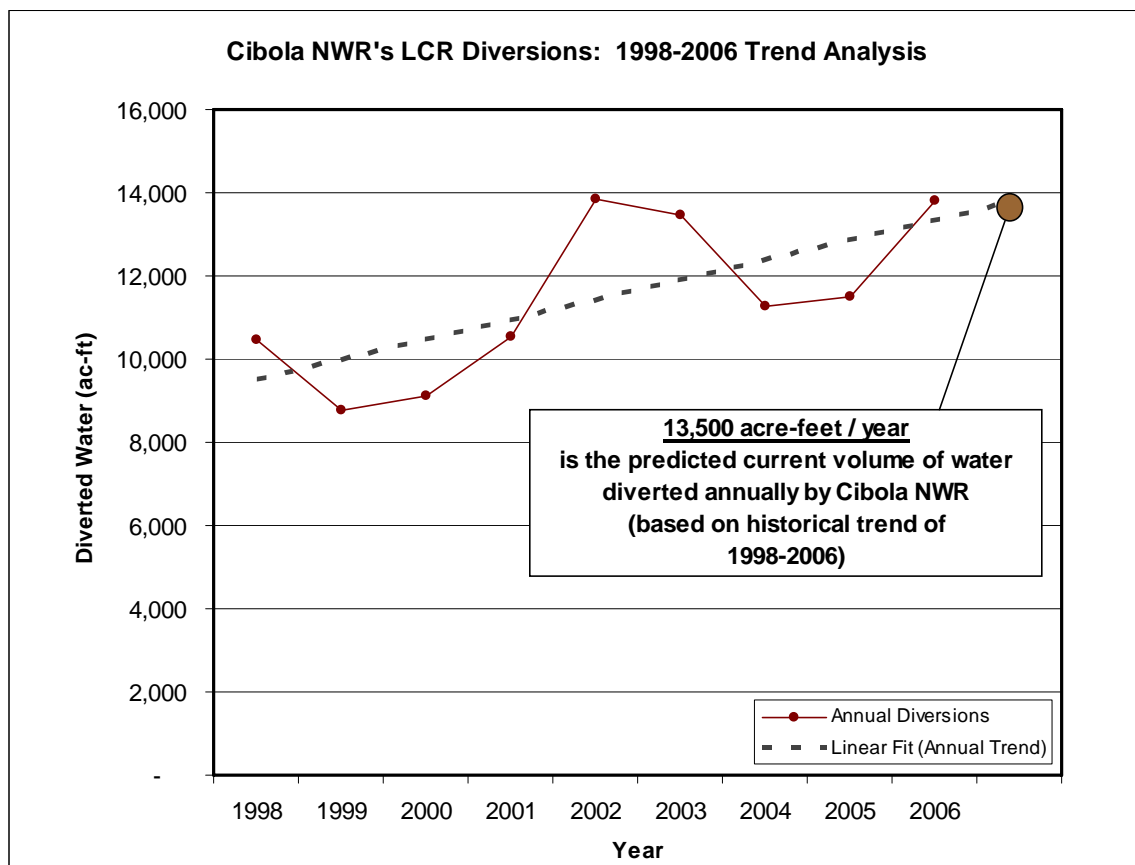
Figure 2. Cibola NWR's lower Colorado River water diversions from 1998 to 2006 showing an overall increase in use due to the addition of new habitat units.

Since 1998, the refuge has added several acres of new habitat, primarily in Farm Unit 1 and the Island Unit. New habitat projects have included riparian vegetation and moist soil units. Predictably, the annual use of water at Cibola NWR has generally increased during that period. Figure 2 illustrates a trend of steadily increasing water consumption.

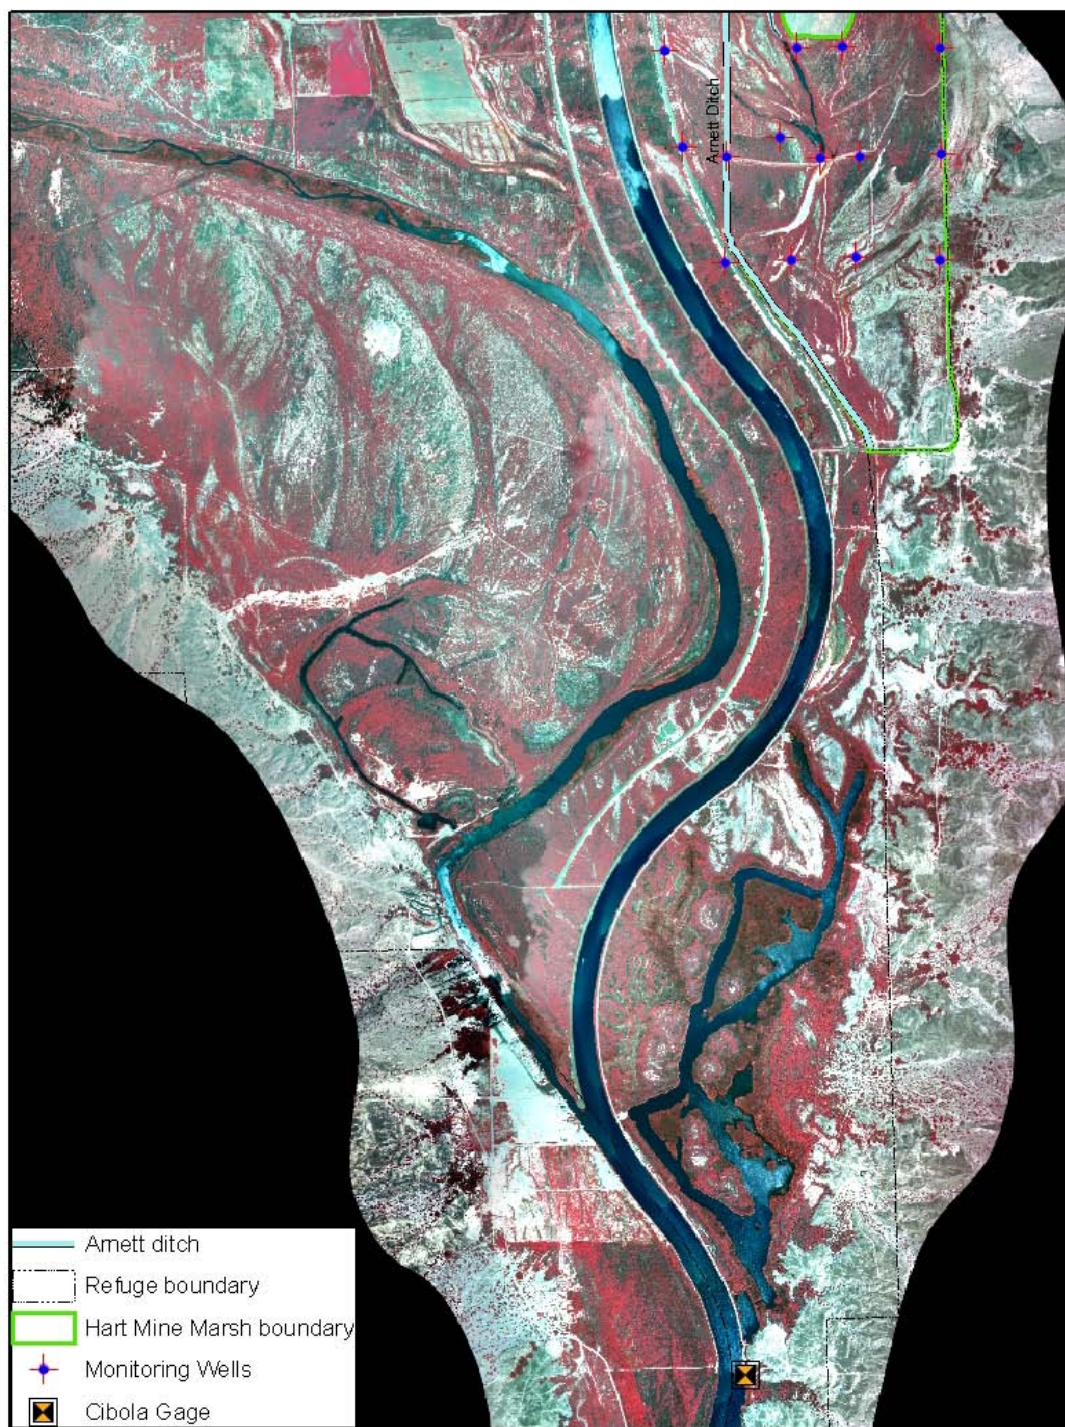
Figure 3. Location of monitoring wells and surface water dataloggers. The USBR's Cibola Gage is located at the lower extent of the image.

At this initial stage of data collection, hourly data from an approximately two week period, from December 13 – 27, 2006, were analyzed. The LCR's role as a control on ground water hydrology was examined using regression analysis. The reader should note that while regression analysis is often used as a statistical model to examine surface and ground water interactions, the approach does suffer from limitations as a statistical model. Hydrologic efficiency, or the "dampening" of surface water fluctuations as reflected by ground water elevations, often creates a scenario where the multiple coefficient of determination ( $R^2$ ) values may suggest that there is not a link between dependant and independent variables when one actually exists. With that said, regression analysis of WSEL data from the LCR and ground water monitoring wells indicates that for the period of time examined, the river is a dominant control on groundwater levels between the LCR and the Arnett Ditch. Monitoring wells HMM\_01 and HMM\_09, located between the LCR and the Arnett Ditch, closely track WSEL of the LCR, with  $R^2$  values of 0.94 and 0.98, respectively.

Furthermore, regression analysis indicates that the LCR river levels exert a control on groundwater levels to the east of the Arnett Ditch: monitoring well HMM\_10 tracks WSEL of the LCR with an  $R^2$  of 0.90. Statistical models for monitoring well HMM\_06

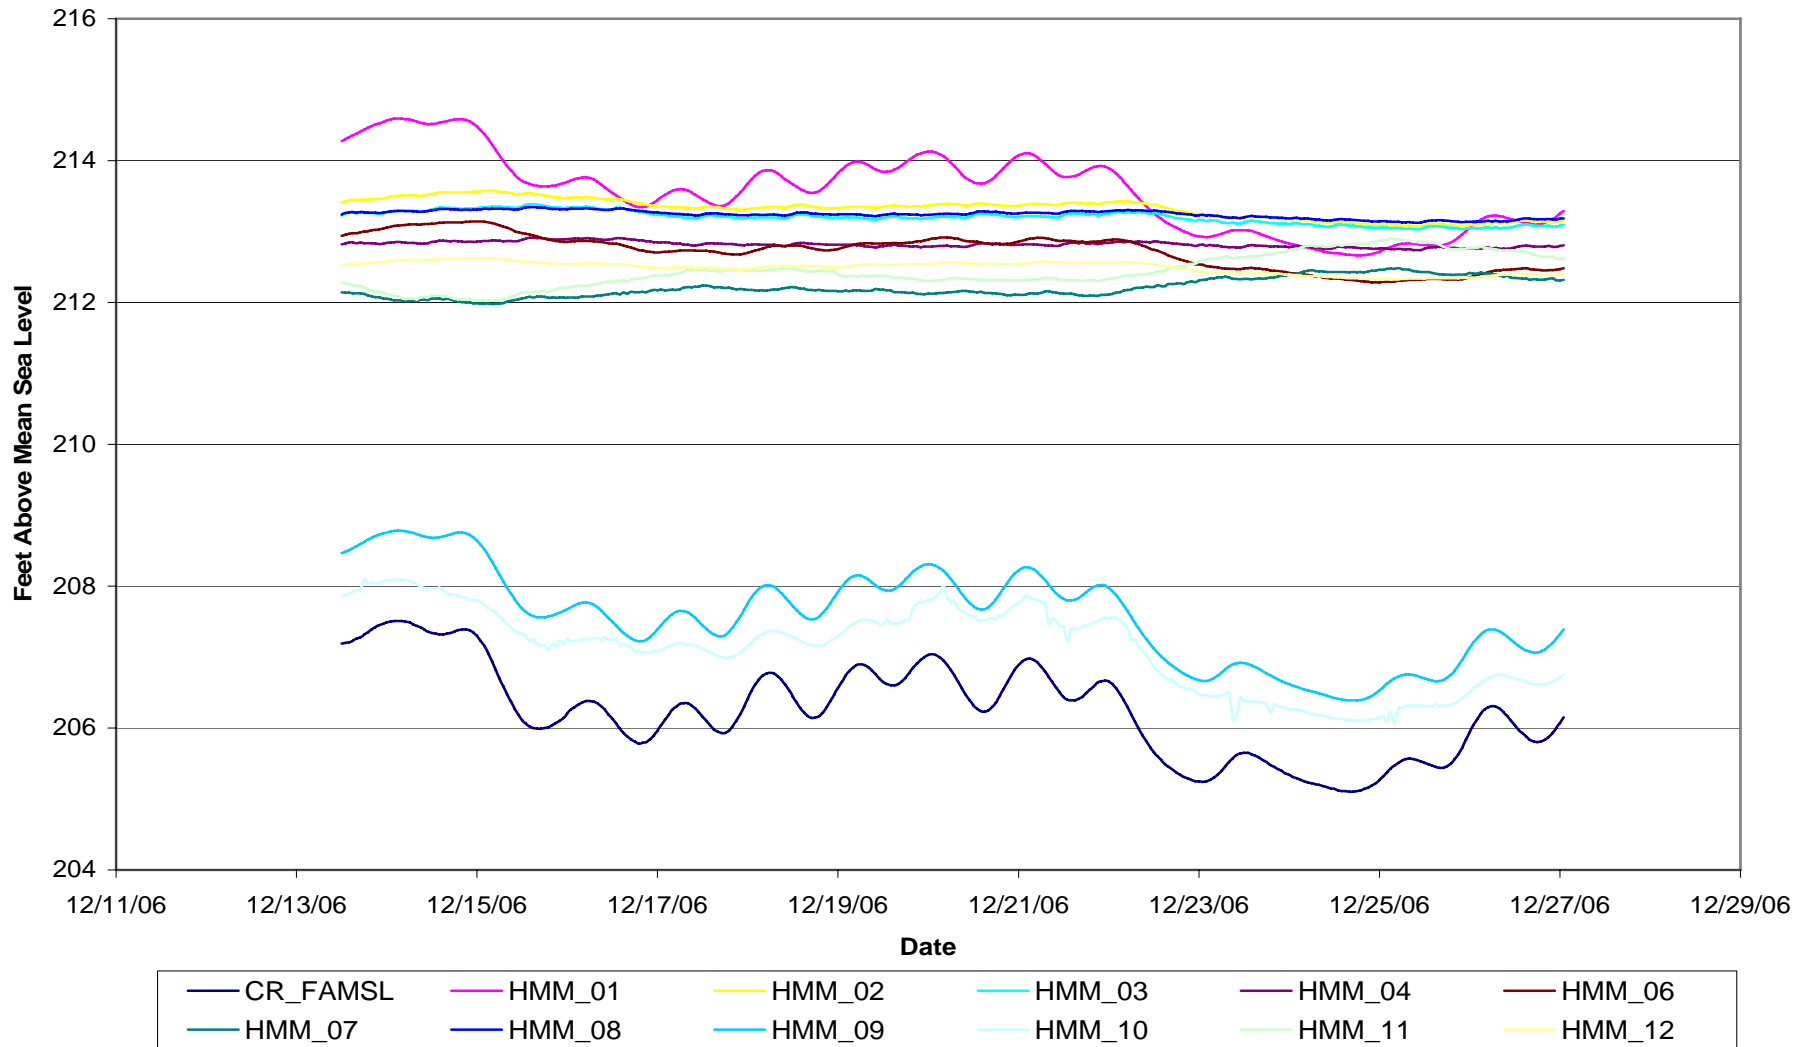
### Hart Mine Marsh Water Surface Elevations: Monitoring Wells and Colorado River

Figure 4. Relative elevations of Hart Mine Marsh ground water monitoring wells and lower Colorado River (at Cibola Gage) demonstrate a clear connection between the LCR and groundwater between the LCR and the Arnett Ditch.

visa-vie the LCR did not produce as good a fit ( $R^2=0.70$ ). The general shape of the WSEL curve for monitoring well HMM\_06 suggests that it is also tracking the WSEL of the LCR, but that there is an overall dampening of the curve. This dampening may be the result of some hydrologic property related to the subsurface matrix. Wells HMM\_02 and HMM\_08 follow the overall WSEL trend, suggesting further dampening of the LCR WSEL curve. The properties of wells HMM\_02, HMM\_06, and HMM\_08 discussed here are mostly speculative and will be subject to further analysis.

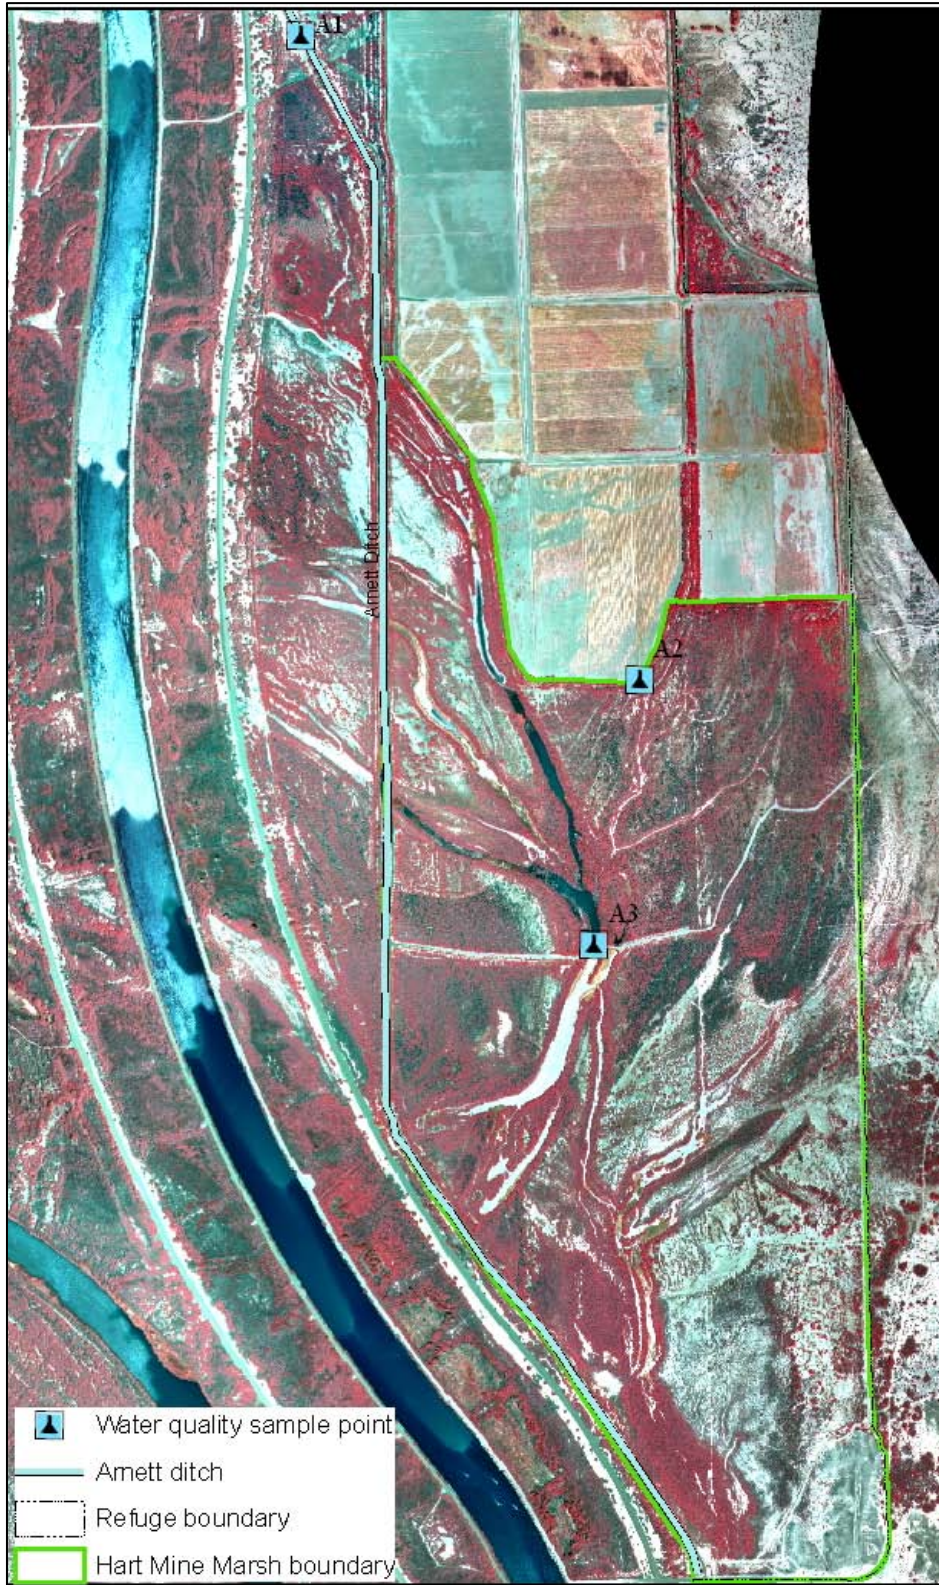
Figure 5. Location of water quality sample sites.

As an aquatic ecosystem, water quality conditions at the Hart Mine Marsh management unit play a significant role in the functioning of existing habitat. To assist with site characterization, water quality conditions were sampled at multiple points in time at the Arnett Ditch, the Farm Unit 2 drain, and the Hart Mine Marsh. The Arnett Ditch is an agricultural drain, and serves as a main source of surface water at the Hart Mine Marsh (precipitation, alluvial fan runoff are other contributors). The ditch originates outside of the Hart Mine Marsh; it forms the western boundary as it flows through the Marsh, and terminates at the southern end of the Hart Mine Marsh. The Farm Unit 2 drain forms the northern boundary of the Hart Mine Marsh.

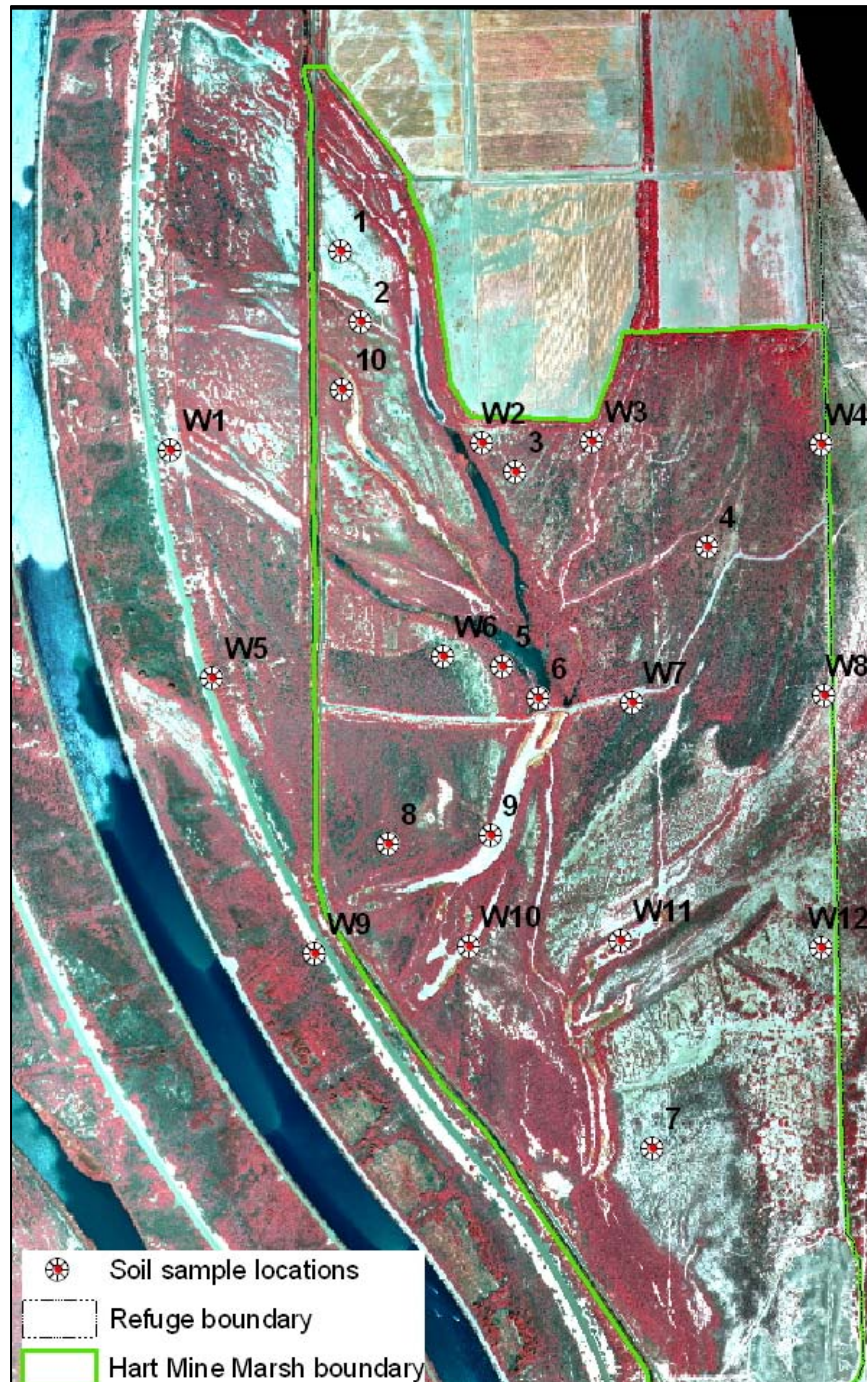
Figure 7. Soil sample locations, includes samples taken from soil pits and monitoring well drill holes.

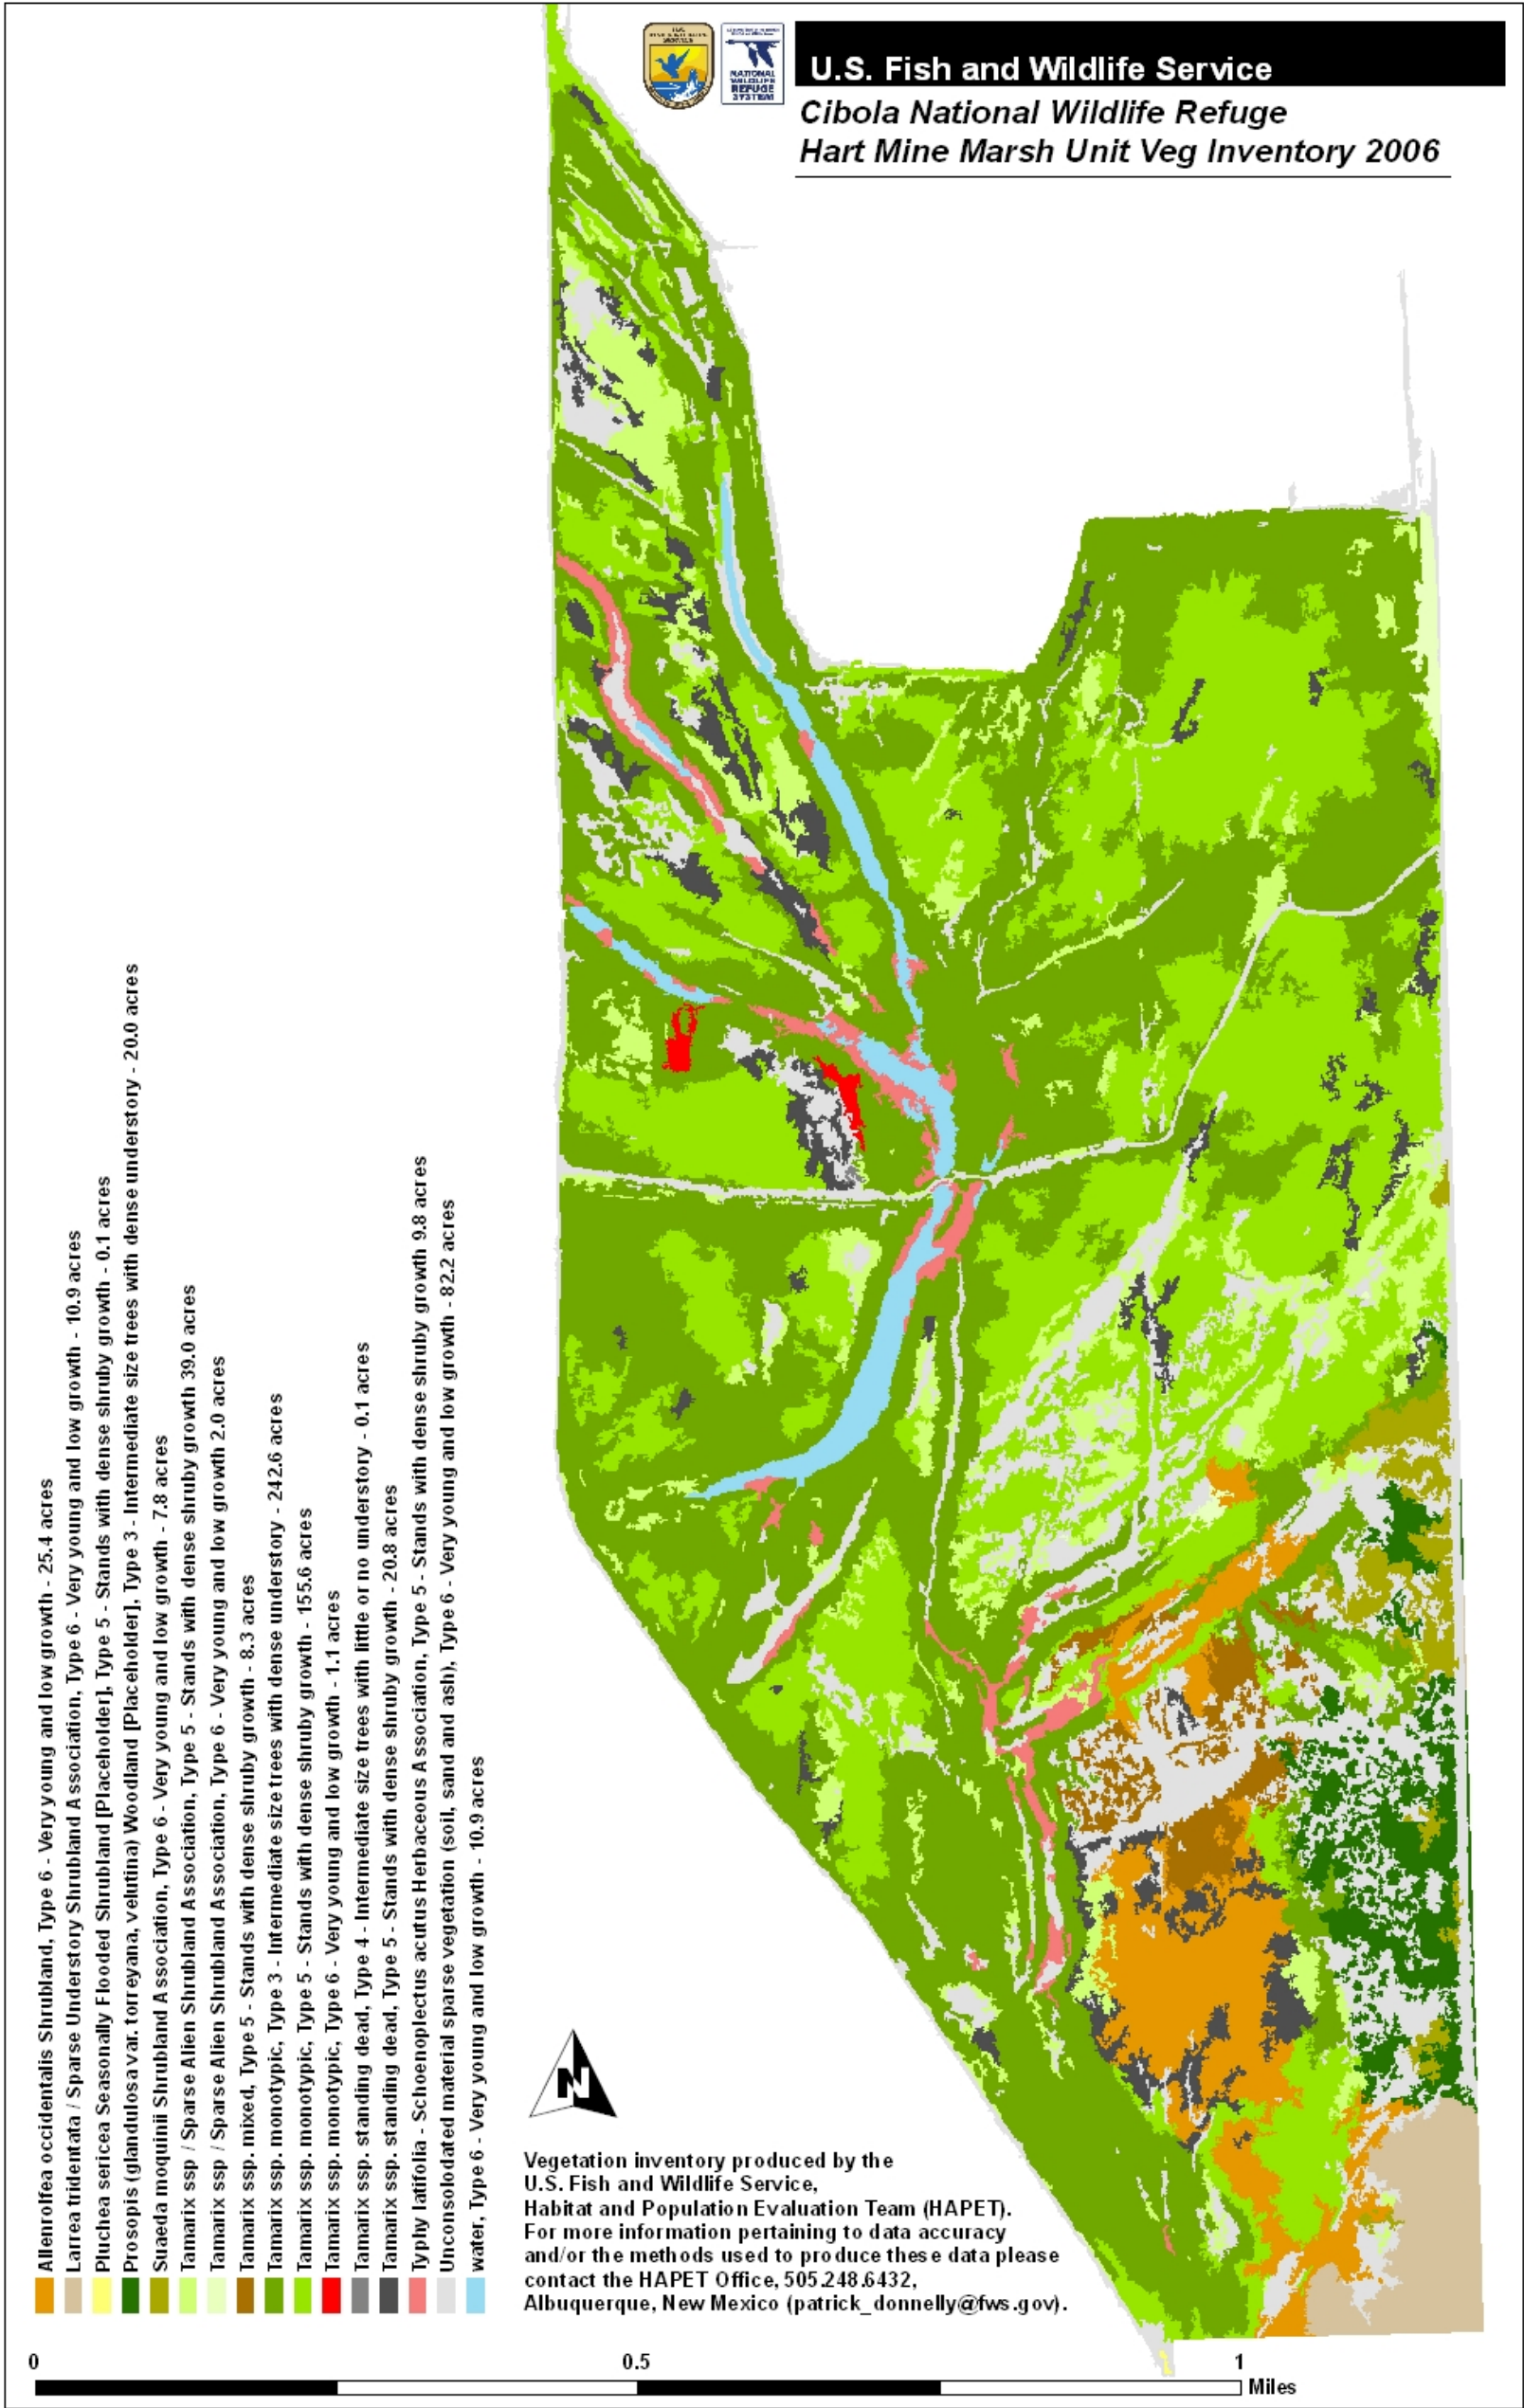
A total of 8 different plant communities were identified and associated with 3 distinct landforms occurring in the unit (Figure 8). The majority of the Unit encompasses the historic Colorado River floodplain. Over 80% of this area has been invaded by mixed and monotypic stands of Salt Cedar (*Tamarix* spp.). The densest and most robust stands of Salt Cedar were found the areas adjacent to active water channels and in lower elevation areas that appeared to pool surface water. Areas directly adjacent to open water or currently active channels contained areas of tall emergent plant communities

dominated by Cattail (*Typha ssp.*) and (*Schoenoplectus ssp.*) Bull Rush (See Appendix 5 for a table of vegetation communities and acreage).

The plant communities on the east central portion of the marsh are influenced by alluvial deposition (alluvial fan) resulting from an arroyo entering the historic floodplain from the east. This portion of the site contains the most plant diversity and appears to be closest to functioning within the natural process of the system, although plant community composition may seem to indicate possible influences from adjacent man made perturbations and disruptions in natural hydrological processes. The eastern edge of this area is woodland dominated by Mesquite (*Prosopis (glandulosa var. torreyana, velutina)*) and Wolfberry (*Lycium ssp.*). Further west the area transitions from a coarse alluvial aggregate to fine. The toe of the alluvial fan is dominated by Iodinebush (*Allenrolfea occidentalis*) and areas of sparse Salt Cedar.
